Demonstration and Validation of Reactive Vitreous Coatings to Prevent Corrosion of Steel Fixtures Attached to Masonry Walls

Final Report on Project F10-AR12

Under Project F10-AR12, "Use of Reactive Vitreous Coatings on Steel Fixtures for
Masonry Wall to Prevent Corrosion at Fort Stewart, GA"

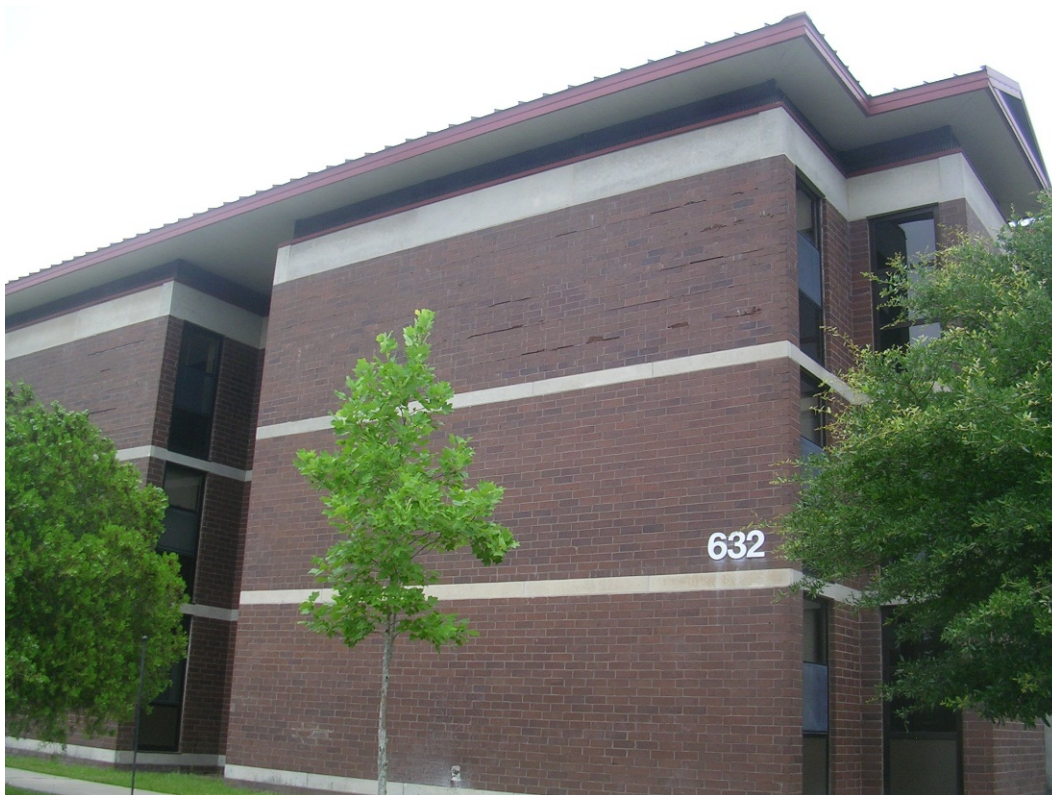
This demonstration involved selecting two buildings that totaled approximately 6,200 sq ft of masonry requiring replacement. The subject buildings had multiple panels of masonry work that displayed visible evidence of failure in the form of fractured/crumbling brick, corroded reinforcing wire, and displaced mortar joints as shown in Figure 1 and Figure 2.

Figure 1. Exterior view of Building 632 brick veneer construction.

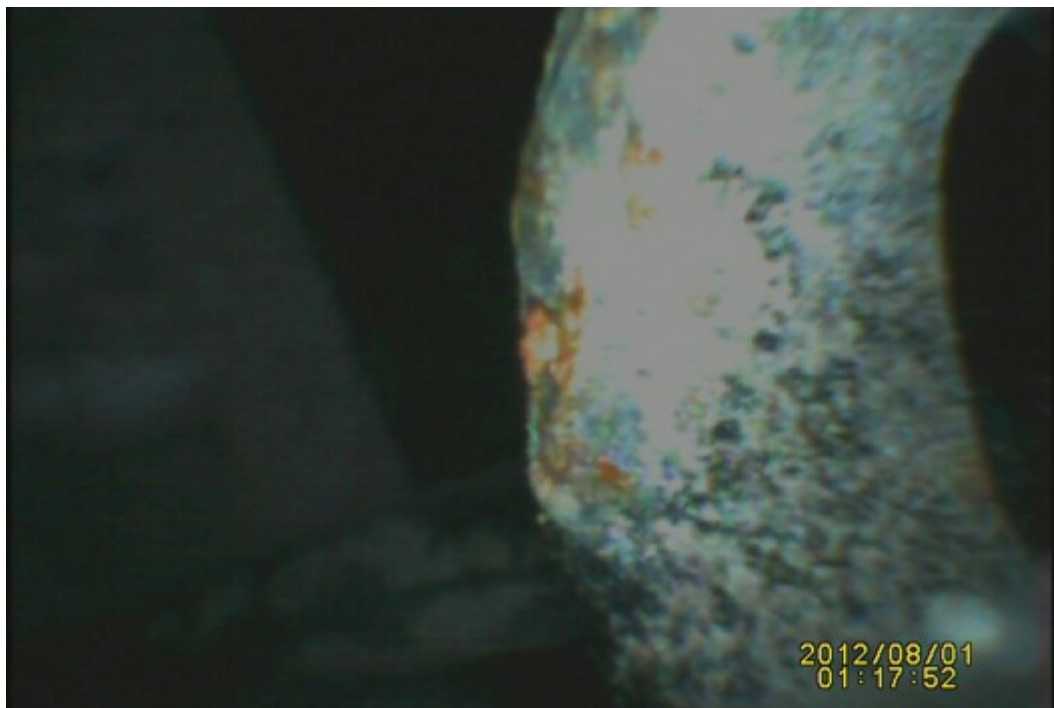
Borescope inspections were completed every 3 months for a period of 18 months after installation. Figure 20 – Figure 27 are images from the final inspection completed in August 2012, and they include eye and pintle components that show the most evidence of corrosion from each inspection location. Individual reports from each inspection are listed in Appendix C. Corrosion was primarily found on the rounded edges of the eye components. The rounded edges are the most susceptible coating imperfections, which was the cause for the corrosion found on items tested. The pintles showed little to no corrosion in all locations. It was also observed that the components experiencing the most corrosion were in locations with the least exposure to sunlight, suggesting that prolonged moisture retention in the masonry may have been a factor.

Figure 20. Borescope inspection of a vitreous coated wall tie after 18 months of exposure in Building 635 location 2-2.

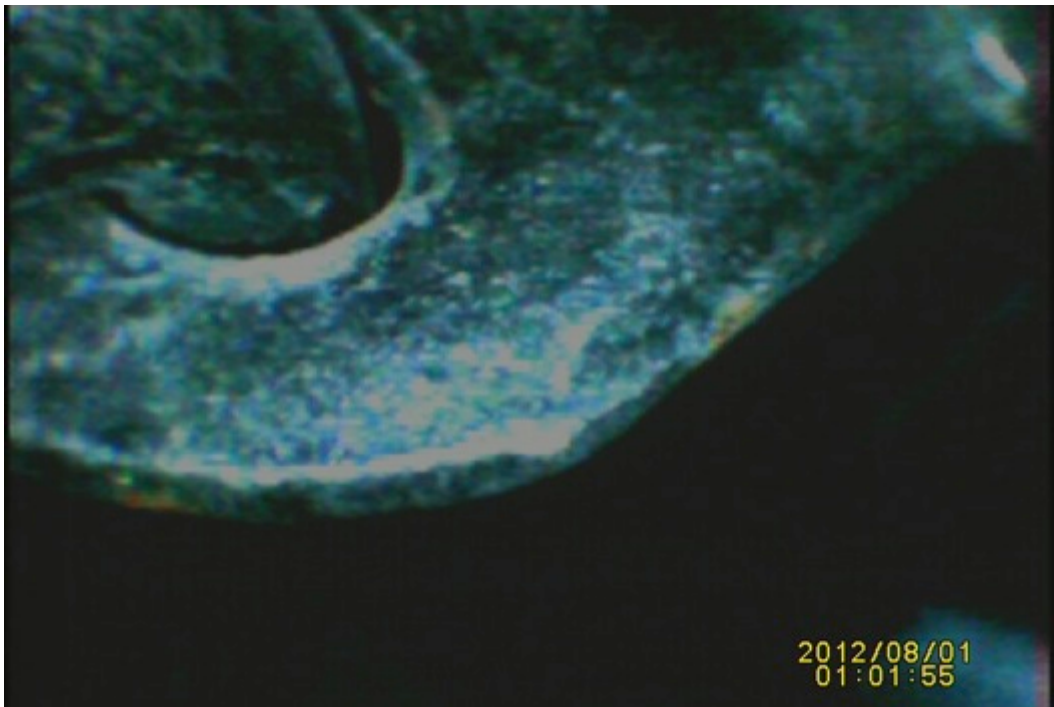
Figure 23. Borescope inspection of a vitreous coated wall tie after 18 months of exposure in Building 635 location 4-1.

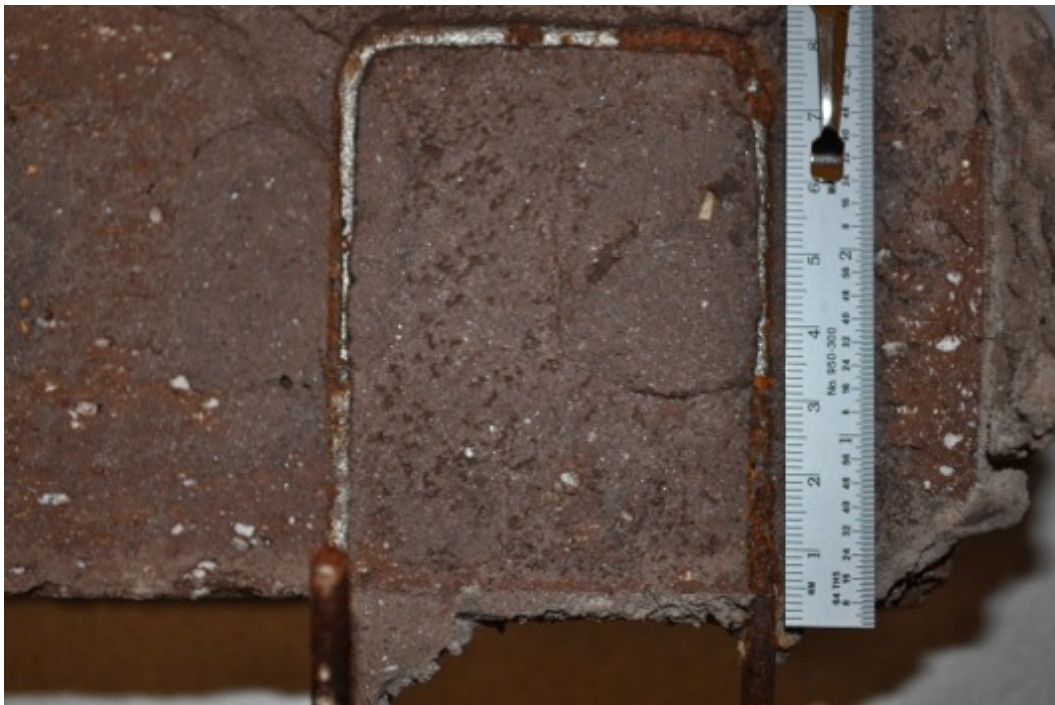
Visual inspections of the brick coupon were completed every 3 months for a period of 18 months after installation. Figure 28 – Figure 37 are images from the final inspection completed in August 2012. Individual reports from each inspection are listed in Appendix C. The brick coupons were broken apart and the mortar was removed from the pintles. The surface area of the standard steel and galvanized pindle that was outside the mortar was 100% covered in rust within 9 months of exposure. The vitreous coated pindle only showed signs of corrosion at the tip of the pindle as shown in Figure 30. The geometry of the tip of the pindle is subject to inadequate coating during application and is the cause of the corrosion. Within 18 months, rust was beginning to form throughout the width of the brick coupon on the standard and galvanized coupons. The vitreous coated coupons did not show any visual signs of corrosion in the interior of the brick coupons.

Figure 28. Destructive inspection of prism interior with galvanized pintle after 18 months of exposure at Fort Stewart.

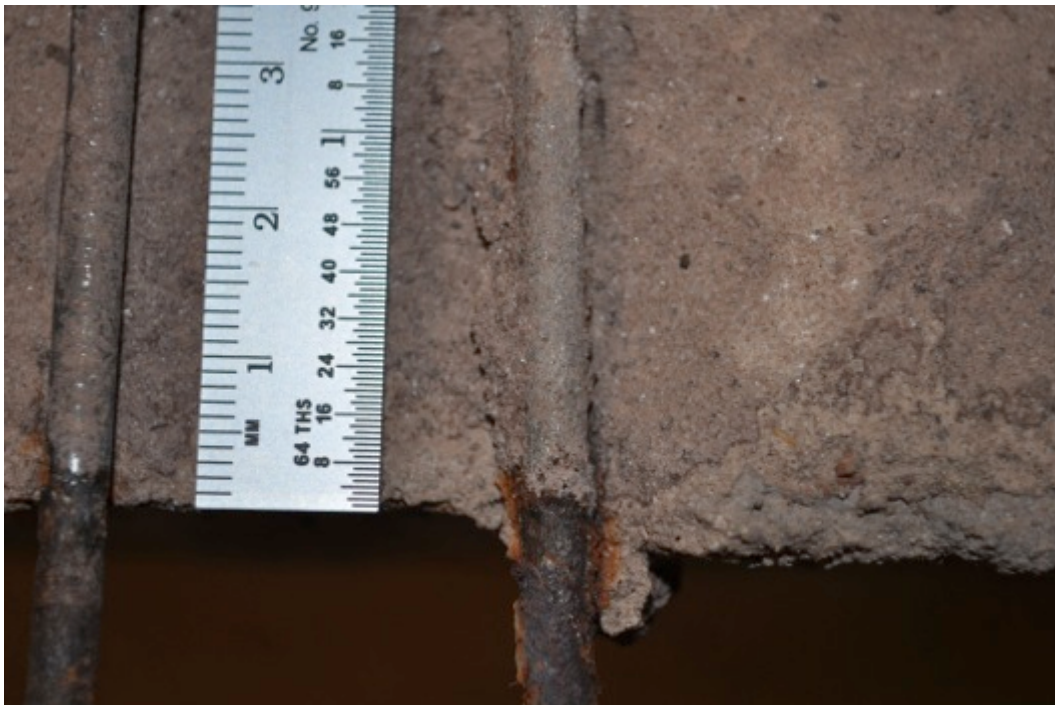
Figure 36. Destructive inspection of the interior of a standard steel (left) and galvanized (right) pintle after 18 months of exposure at Duck, NC.

Destructive inspection of some of the 20 comparison coupons (i.e., those containing one bare steel, one galvanized steel, and one enamel-coated steel tie assembly) revealed galvanized pintles that were corroding faster than individual galvanized ones in specimens earmarked for ASTM E754 testing, such as the one shown in Figure 38.

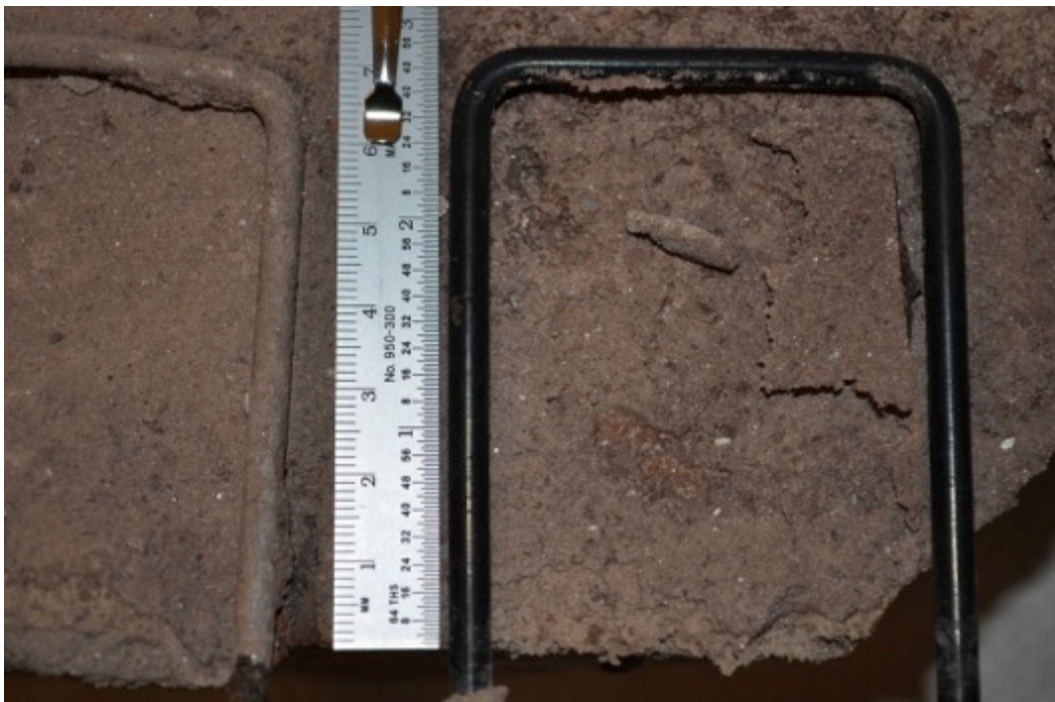
Figure 37. Destructive inspection of the interior of a galvanized (left) and vitreous coated (right) pintle after 18 months of exposure at Duck, NC.

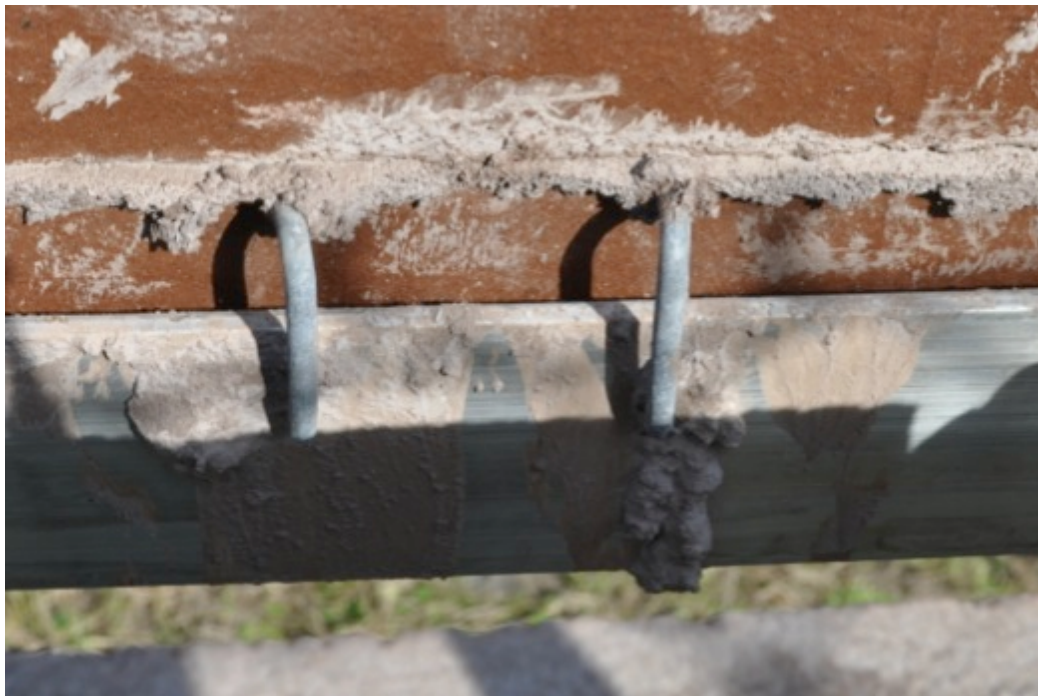
Figure 38. Solo galvanized pindle in an ASTM E754 brick coupon at Fort Stewart, GA.

It was determined that the presence of the uncoated steel pindle inside the same coupon as the galvanized one created a corrosion cell when moisture was present in the mortar to serve as an electrolyte and conductor. The

zinc coating of the galvanized pintle had begun to sacrifice itself to protect exposed steel in both pintles. Corrosion-cell current was confirmed by connecting a multimeter to both materials. Because the vitreous enamel coating is an insulating material, no current should have been able to move between the galvanized pintle and the coated one as observed. To verify that corrosion current was affecting the coated hardware, a tip was cut off and voltage measurement was taken between the exposed substrate and the standard steel pintle; the recorded voltage was similar to the current between the bare steel and galvanized specimens, suggesting the presence of a break in the vitreous coating undetected through visual inspection.

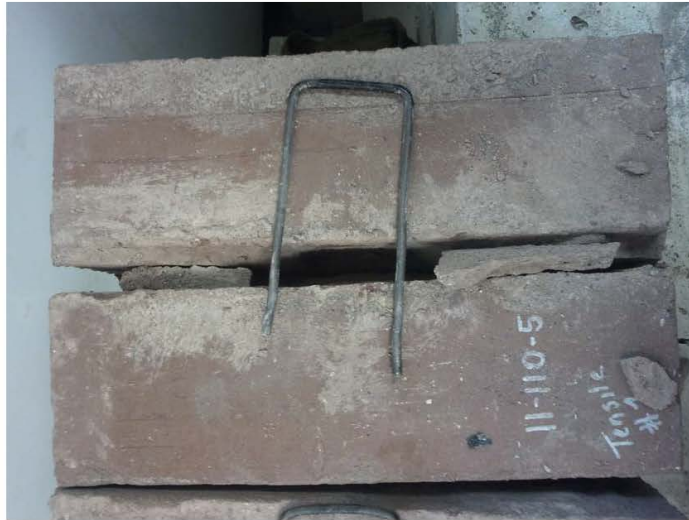
Photo 2 – Mortar Joint Shear

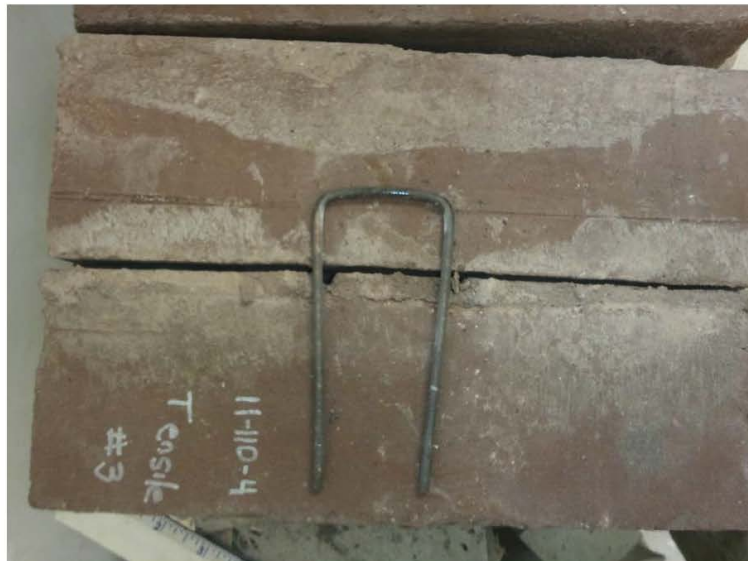
Photo 3 – Mortar Bond Failure on One Side

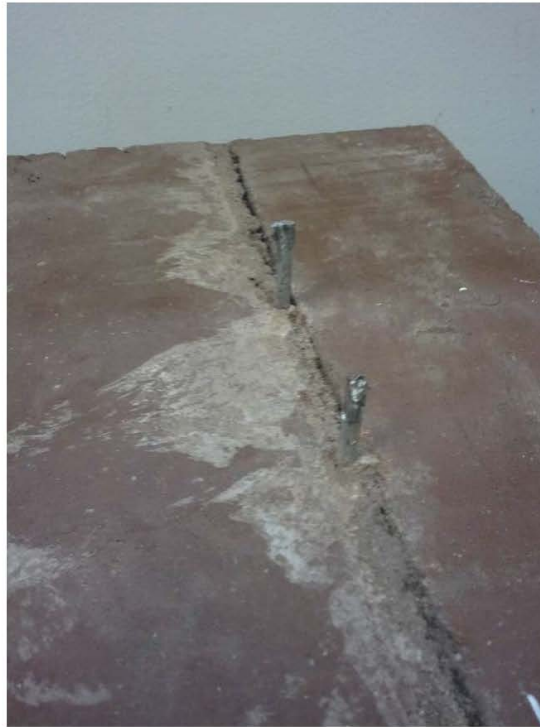
Photo 4 – Metal Tensile Failure
